Field Reports

Glenrock Colliery Railway, Glenrock, NSW

Mount Ainslie Quarry, Canberra, ACT

Sun Ray Salt, Lake Gerahmin/Lake Daytrap, Swan Hill, Victoria

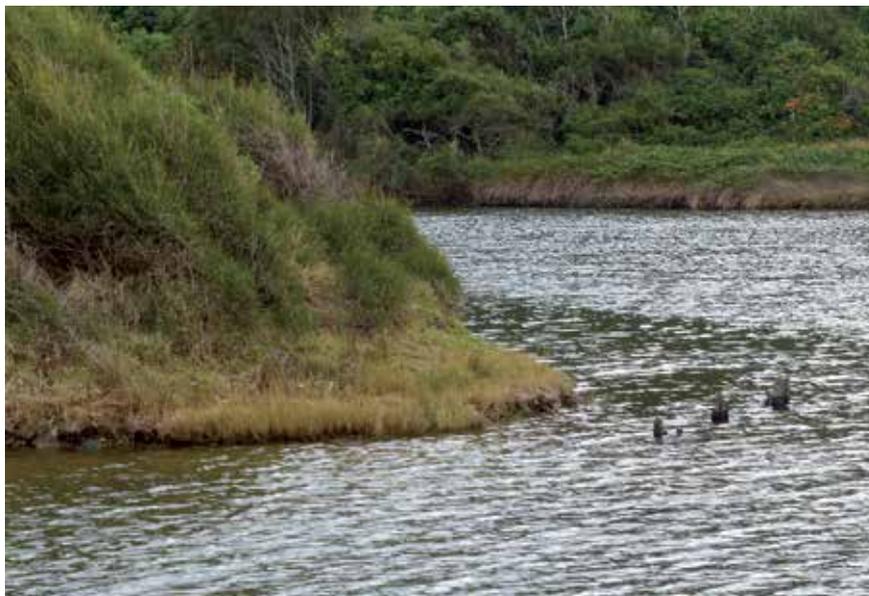
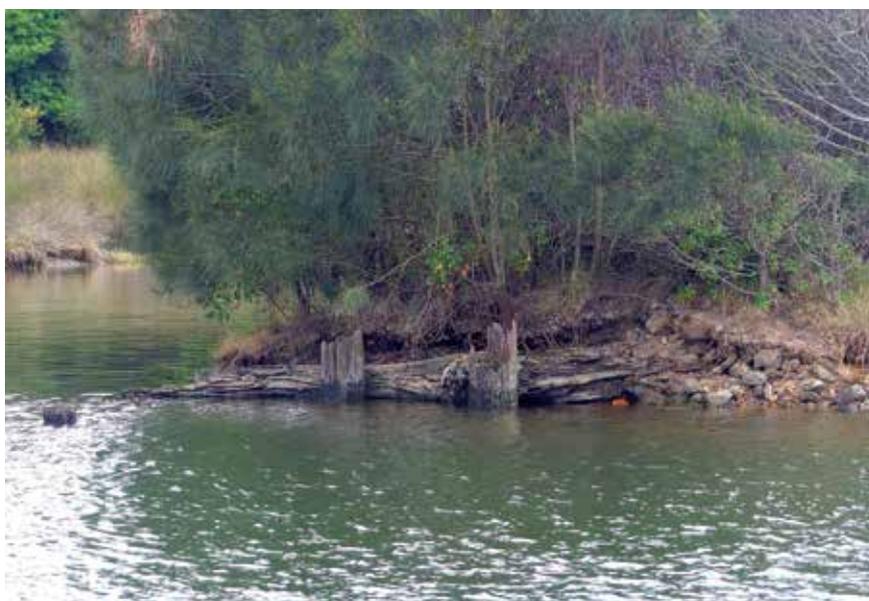
The inland and coastal bridge abutments where the Glenrock Colliery Railway crossed Glenrock Lagoon between the Glenrock and Burwood Collieries.

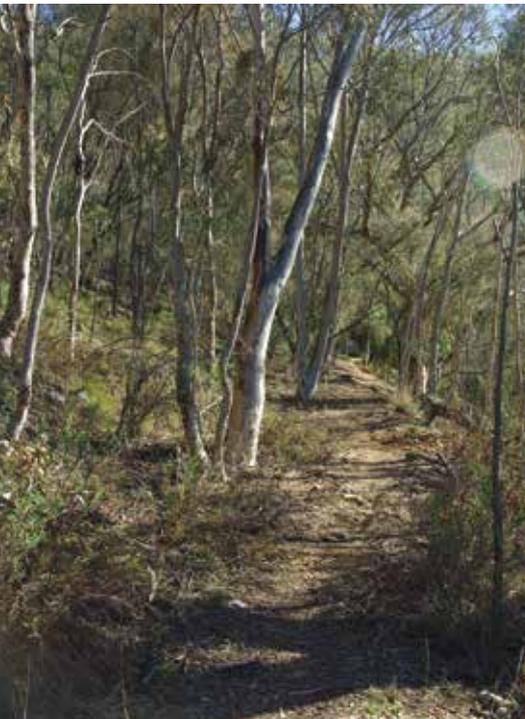
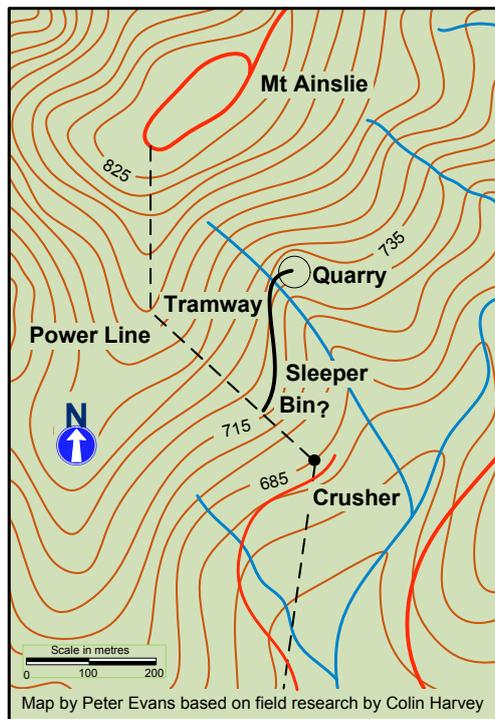
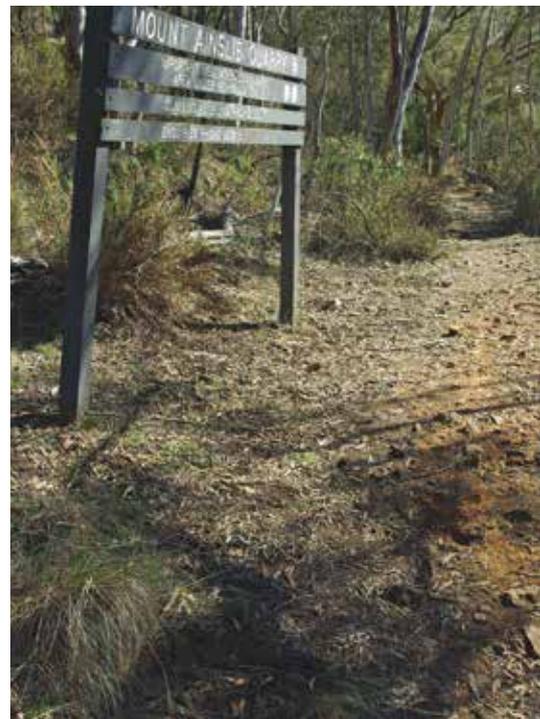
A visit to the Mount Ainslie quarry, within the Canberra Nature Park, in September 2013 revealed the tramway formation to be easily followed from the quarry to a point on the hillside above the concrete foundations of the crusher. Evidence for the arrangements for feeding rock between the tramway and crusher has been obscured by later construction of a power line. At the quarry one length of about 10kg/m rail was located (MGA 696513E 6094667N) and at least one sleeper remains in situ along the tramway route (MGA 696476E 6094561N).

Clockwise from bottom left: A section of rail from the Mt Ainslie Quarry tramway. • Looking north along the tramway formation towards the quarry. • At the foot of this photograph (and almost obscured by the tussock) is a remnant sleeper on the tramway formation. Photos: Colin Harvey • Abandoned rails across the flats at Lake Gerahmin/Lake Daytrap. Photo: John Dennis

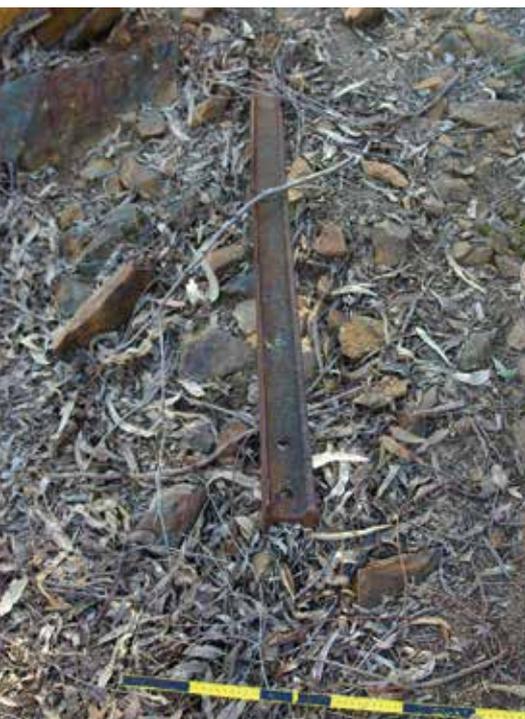
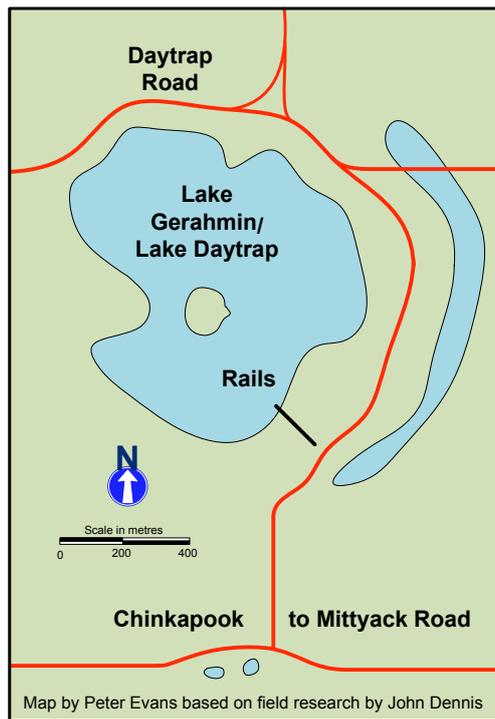
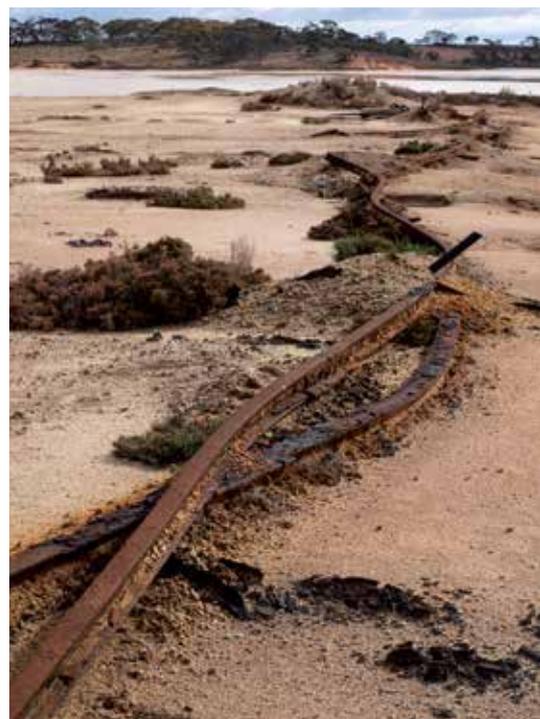
On 15 May 2013 I visited Lake Gerahmin (aka Lake Daytrap) where, following reports of tramway remains, I made an inspection. There are about eighty metres of rail which appear to have been pulled off the sleepers, and moved five or ten metres to the side.

There is about 100 metres of formation, clearly defined, with some sleepers (or remains of) visible. The rail looked to be quite heavy, as were the sleepers, which suggests that it might date from closer to the end of operations in 1970 than earlier. From my photographs the heavily corroded rail is about 115mm high, 105mm across the base, and 65mm across the head. These
